SAFETY ALERT

Near Miss **Paper Machine Primary Arm Clamp Failure**

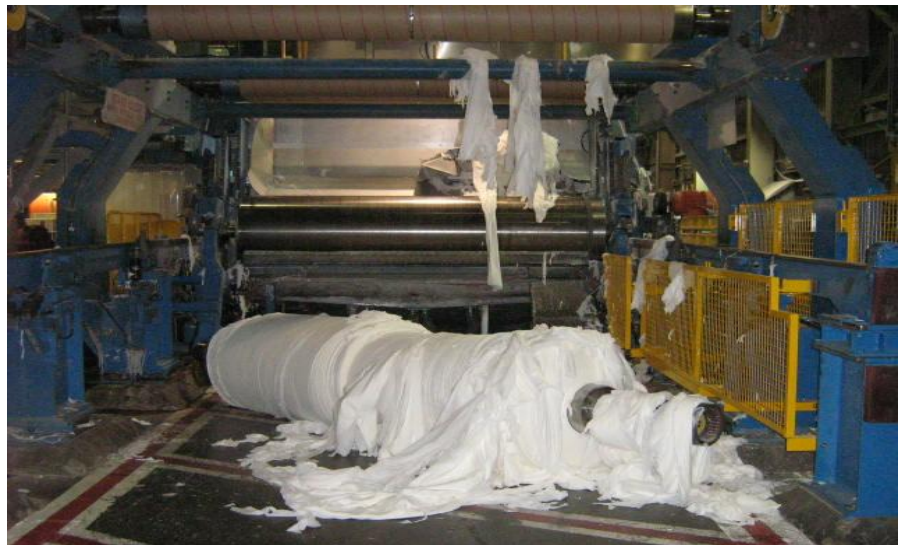
On the 10th of February a partially built reel of paper fell from a paper machine to the floor while the machine was producing paper. The reel weighed approximately one (1) tonne and could have caused significant harm to people and equipment had the circumstances been different.

- Front portion of the Voith tail threader was bent.
- UTM guard bent.
- Spindle was taken out of commission until confirmation of no damage sustained.

Ejected reel on floor between the rails

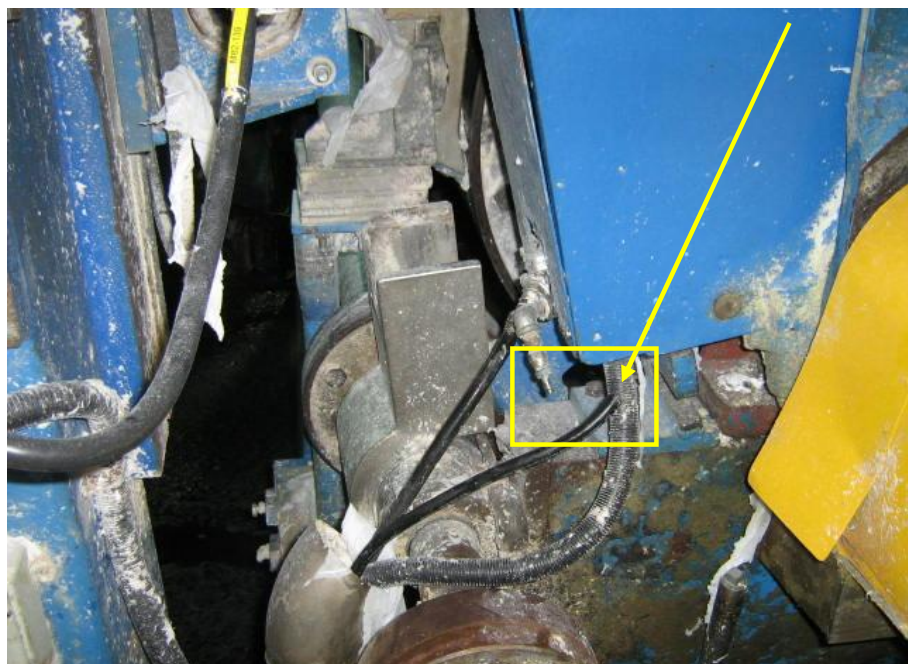
Immediately following the near miss incident it was found that the air hose on the back side of the primary clamp cylinder had come off the fitting. This pipes the air, which in turn drives the primary arm clamp up and down, meaning the primary arm clamp could not release to return to its home position above the reel drum.

Airline to B/S cylinder (to open primary arm clamp) came off fitting

2. Upgrade air hoses and connections on primary arm systems; front and back. In addition a rearrangement of the primary arm cylinder cover for the access of the air hose is required. The way the cover is currently set up there is a risk that the air hose will again loosen itself from the fitting.
