WISE NEWS

Workplace Industrial Safety and Environment Newsletter

SAFETY ALERTS

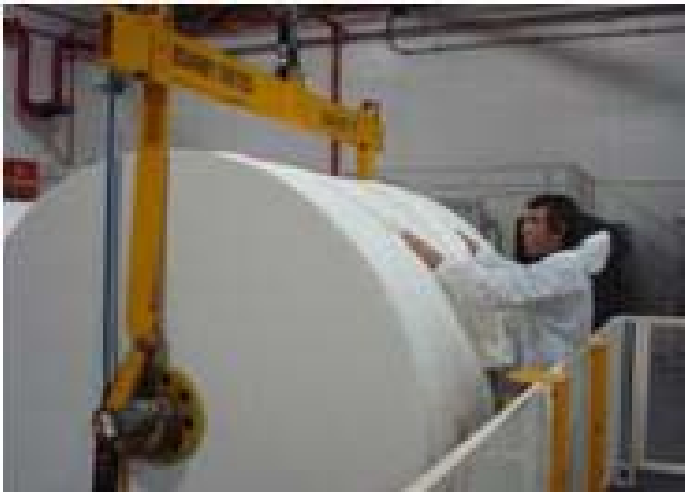
Operator Pinned between Parent / Hard Roll & Safety Fence

An operator was recently pinned between a parent/hard roll and a safety fence when the roll moved forward unexpectedly. The operator suffered bruising and soreness but was able to return to work on alternative duties.

They were dressing the roll in preparation for loading into the machine. There were two (2) rolls in the staging bay, one (1) of which was being dressed by the operator. A forklift then delivered a third into the bay. When exiting the immediate area the forklift struck the rolls, causing them to move forward and trap the operator against the safety fence.

- Forklift driver did not see the operator
- Constricted area
- Door opening mechanism does not identify forklifts in the area
- Too many rolls in area
- No 'safe zone' between the roll and fence

- Dome mirror fitted to improve visibility of operators on this machine and others on site
- Floor markings to be improved
- Only two (2) rolls in the staging bay at any time
- SOPs updated to include only two (2) rolls in staging bay at any time and operator to cease dressing rolls and exit bay when forklift is present
- Creation of a safety zone with the installation of two (2) bollards, one metre out from the safety fence
- Door operation to be reviewed
- Site-wide pre-operation check system by fork lift drivers
- Other machine hard/parent roll staging bays to be reviewed.

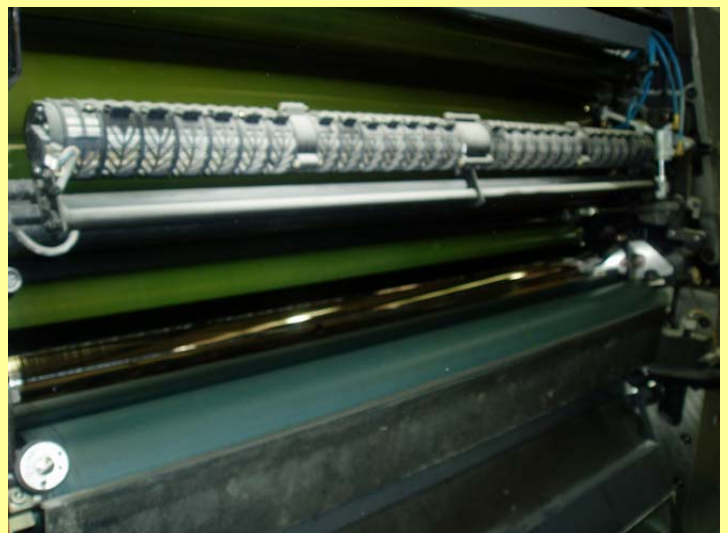
On Site Amputation

An operator's arm was dragged into a printing press while he was operating a four colour printing press in the United Kingdom recently. The arm was drawn into the press between the plate cylinder and the inking roller. Emergency services were unable to free the injured person's arm and it was decided to amputate the arm at the scene of the accident.

The operator was working alone and there were no direct witnesses to the incident. However, it is believed that he may have been trying to remove dirt from the rotating plate with a piece of card whilst the machine was operating at speed. The guarding was inadequate and the extension guard which normally sits at the feeder side was missing.

- Up-to-date activity based risk assessment for any physical intervention relating to the feeder running nip area.
- Documented safe systems of work for access to cylinders and inking rollers during cleaning, preparation and maintenance tasks.
- Guarding standards review for all feeder and extension guards.
- Regular auditing schedule for guarding systems.
- Training audit and review.
- Review of supervision arrangements to support risk reduction program.

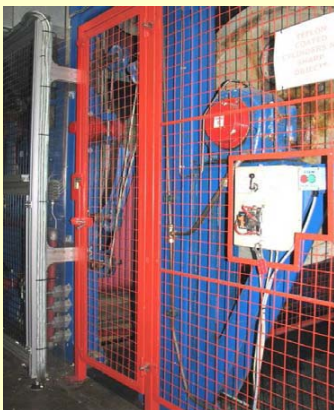
Access Gate

An operator was fatally injured while attempting to remove broke paper from a drying cylinder. The deceased operator was attempting to remove paper from a drying cylinder and became trapped between the drying cylinder and a dryer fabric roll. The area is protected by a gate guard which is secured by a padlock to prevent access when the paper machine is running. The deceased went through the gate to enter into the area inside the paper machine while it was running. He died later in the hospital from his injuries.

System for control of keys used to unlock safety guards would be changed to ensure access to hazardous area is prevented.

Complete review of guarding carried out to identify where improvements could be made.

Replace padlocked guards with either fixed or interlocked guards where access is required on a regular basis.

Review operator training procedures for **non-routine tasks** to ensure that they are current.

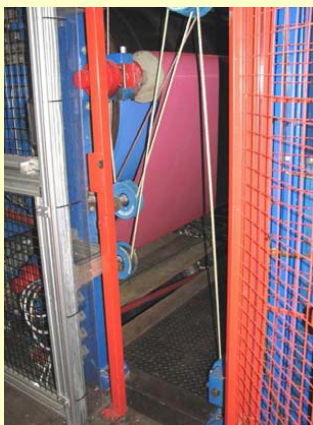
General view of the area with the access gate open

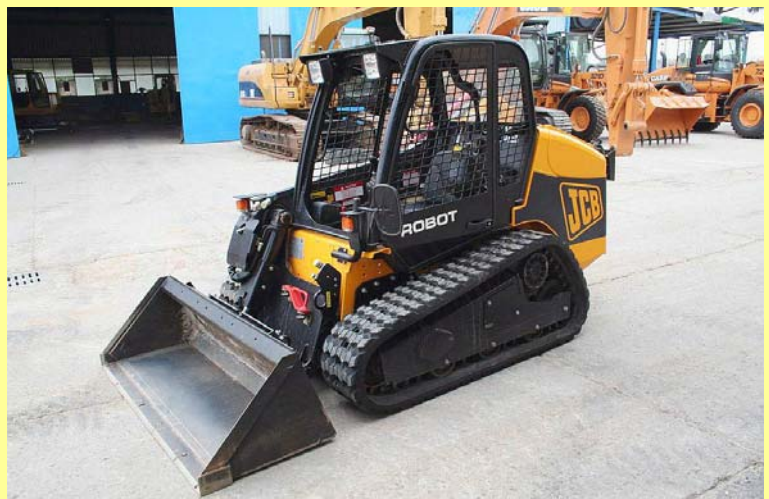
Skid Steer Loader Fatality

This alert comes out of the United Kingdom and informs about a fatality where an operator was crushed by the lift arm of a skid-steer loader. The arms and bucket tilt mechanism on skid-steer loaders present potential crushing and shearing hazards when they are moving. Cab fronts are not always enclosed and often entry/exit is via the cab front. Hence, operators can potentially be exposed to these hazards if they lean out of the cab front or, as they exit the cab on front exit/entry machines. People who approach the machines whilst it is operating or perform maintenance are also at risk from the crushing hazards.

The skid-steer loader in question was fitted with a foot pedal control directly linked to a hydraulic valve. The spool inside the valve should have been locked by an electrical solenoid activated by raising the restraint bar. During the investigations it was found that raising the restraining bar failed to engage the spool lock leaving the pedals active – that is the operator could still operate the lifting arm and tilt mechanism using the pedals even though the restraint bar had been raised. This only occurred if the foot pedals had not quite returned to their neutral position before the restraint bar was raised. When not in neutral, it was found that the solenoid could not engage with the valve's spool.

- Even on an adequately maintained machine, the operator may inadvertently rest their foot on the pedal, thereby holding it off neutral.
- Poor maintenance or a build up of material can increase resistance on moving components of the pedal linkages.

- Always lower the bucket or attachment flat to the ground before anyone approaches the danger zone created by the arms or tilt mechanism.
- Ensure that not only is the safety bar raised but that the pedal interlock has actually engaged before anybody approaches the danger zone.
- Undertake daily checks of the interlock.
- If the pedals are found to be active with the restraint bar raised it is likely that the pedals are not returning to neutral. This is a potentially dangerous fault and the machine must be taken out of services until the fault is rectified.
