# WISE NEWS

Workplace Industrial Safety and Environment Newsletter

# SAFETY ALERTS

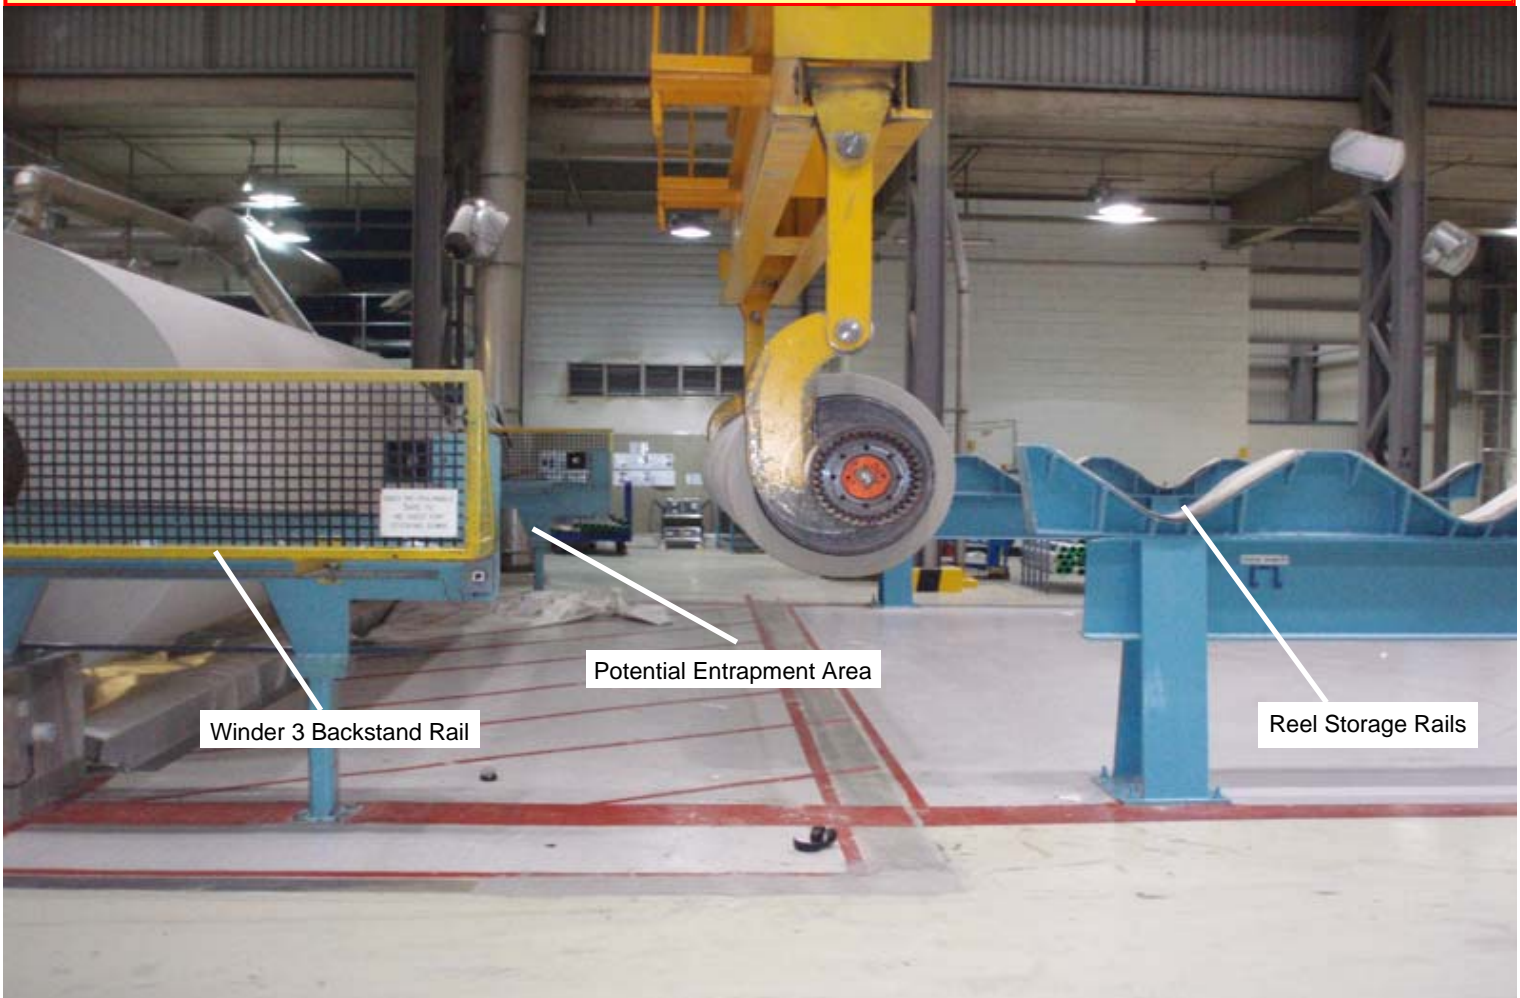
## Paper Machine Reel Spool Incident— Serious Facial Injury

On 2nd February, a paper mill employee suffered a broken jaw and crush injuries to the mouth and cheek bone, when his head came into contact with a reel spool, while in the process of preparing a small reel of paper for storage. The combined weight of the reel spool and paper involved was approx 1.35 tonnes.

The incident occurred between 'Winder 3' backstand rail end, and the paper machine reel storage rails behind Winder 3. The injured operator, an experienced dryerman, had used the crane, with a remote control box, to remove a small reel from the Winder 3 backstand rail. The reel was then suspended in the crane hooks at head height close to the backstand rail end while

the operator dressed the reel and disposed of any paper broke. The detail is not clear, as all witness accounts are not yet available, but whilst the operator was leaving the area the crane moved and the operator's head was caught or struck by the reel spool in the area of the Winder 3 backstand rail end.

In the meantime the company has taken the following actions:

1. Full crane function checks have been carried out by service engineers from Kone Cranes; these proved all clear and the crane was put back in service.
2. Work instruction has been re-issued to avoid all working on reels that are suspended in the crane hooks e.g. For dressing reels and taking lab samples.

3. If working on a suspended reel is necessary, then the crane emergency stop must be activated.

Taking samples and dressing reels is a common everyday practice in the industry which until now may have been considered a low risk activity. However, all companies are now strongly advised to review their current operating procedures against the above information, in particular the practice of working on or near any suspended load.

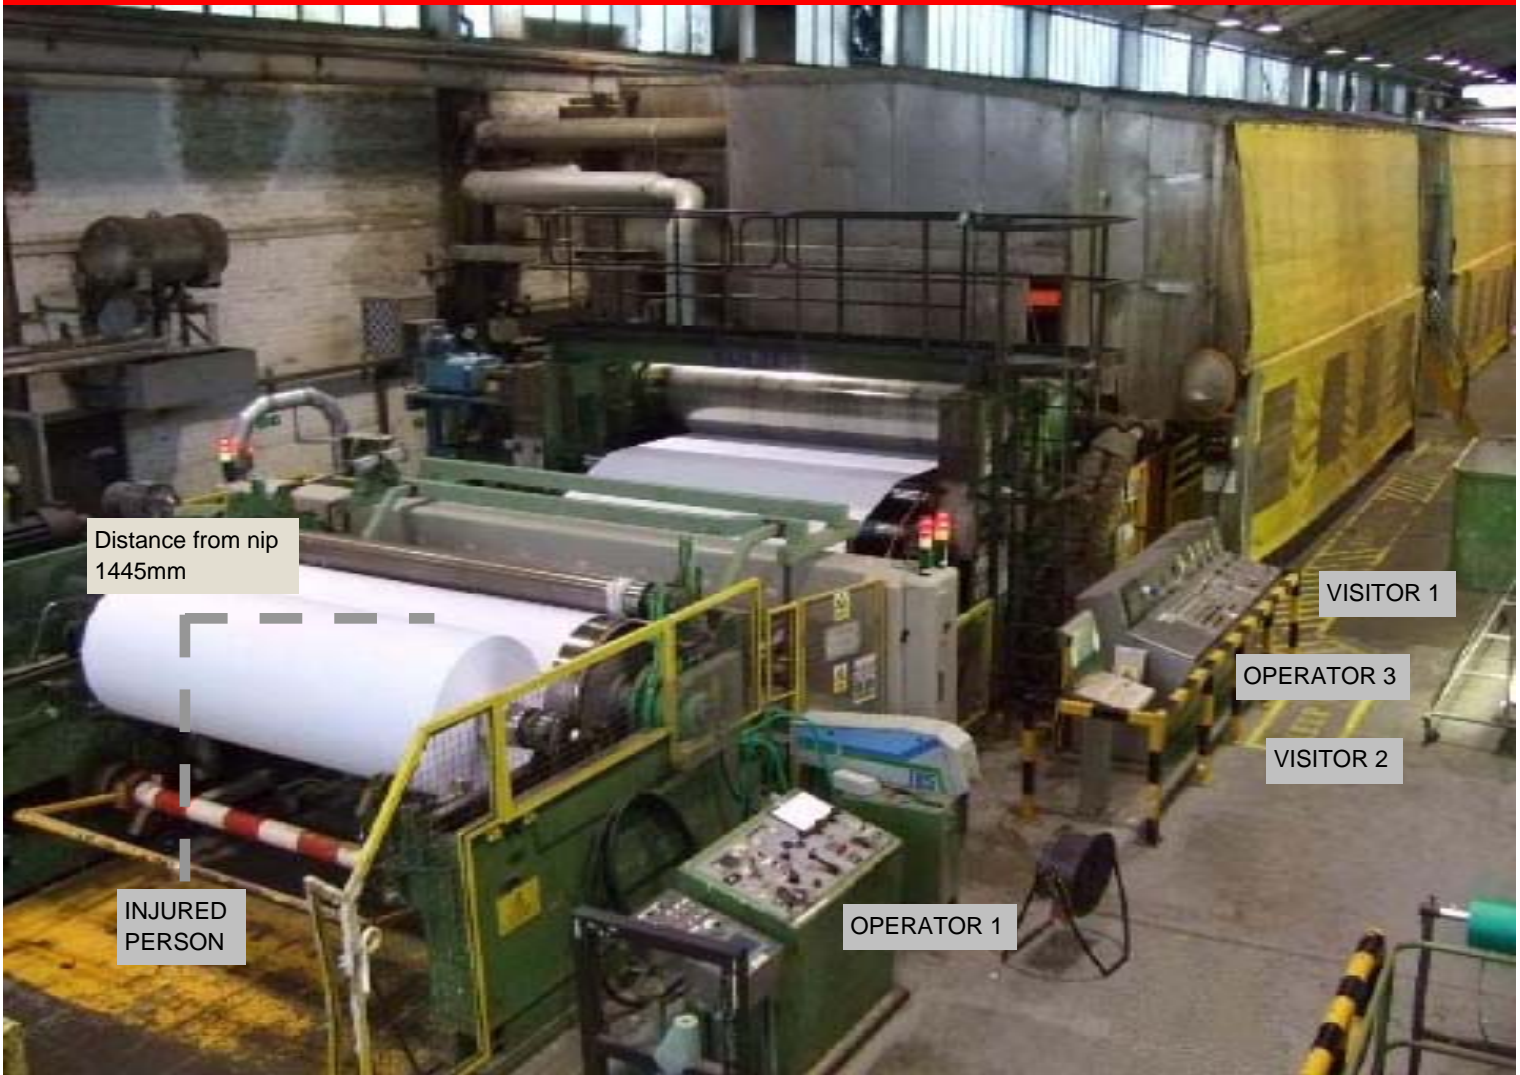
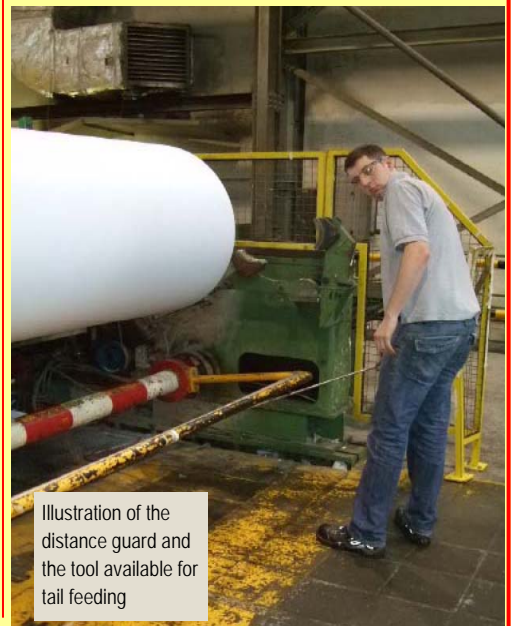
## Paper Machine Incident—serious injury to lower left arm

Following a paper break at Paper Machine (3), an employee sustained a serious injury to his lower left arm. The injured person was tidying up paper tails at the reel up area. During the process of sheet transfer to the new shell, the paper failed to blow up into the nip point aided by the tail feeding device. The injured person then attempted to throw the sheet over by hand. During this process it appears he became entangled within the heavy gram sheet, which resulted in his arm being pulled across the shell and into the nip point between the reel shell and the reel-up drum. A colleague hit the emergency stop button and released the secondary machine arm, so as to release the shell from the drum. The injured person was released from the machine and given first aid treatment until an ambulance crew arrived, he was then stabilised and immediately transferred to hospital. The medical staff at the hospital performed a surgical operation which resulted in amputation of the lower left arm at the elbow.

- ◆ Machine break
- ◆ Heavy grammage grade 160 gsm Very small shell (not as illustrated)
- ◆ Blower system/sheet feeding device ineffective at heavy grammage
- ◆ Operator assistance required to feed sheet to shell
- ◆ Tools available for assisting sheeting into nip point
- ◆ Procedures established, however not fully effective on heavy grammage
- ◆ Current guard creates effective distances (at knee level)

- ◆ Immediately put in place a procedure to ensure risk is reduced at PM3 reel up (this was done before machine was restarted)
- ◆ Review of risk assessments for all nip points on PM3 machine and at PM4
- ◆ New procedure for blowing full sheet on to shell
- ◆ Complete safety briefs will all crews making sure that they are fully aware of the incident and all corrective actions

- ◆ Investigate the possibility of increasing air flow and pressure to improve the reel up blower system
- ◆ Repainting of the floor at reel up guard with message clearly stating “**NO ENTRY**”
- ◆ Review guard design—consider as a design which creates a physical barrier rather than just a distance obstacle
- ◆ Review and standardise tools associated with this task

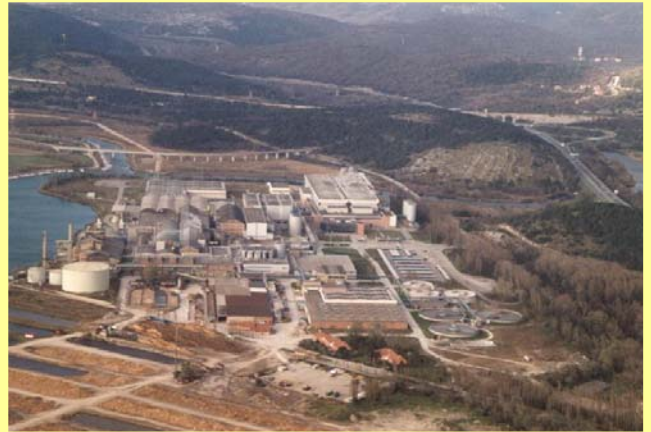
## Italy: Fatal accident after fall into sawing equipment in a pulp mill

**Facts (\*):** Initial inquiries were under way to determine the causes of the accident. For process reasons related to the Duino mill, wood trunks have to be cut into logs of 1 metre length. The sawing is done inside a 10m tall structure. IP was supposedly on a platform at height when he apparently fell into the sawing equipment. The emergency stop system of the saw failed for reasons not yet clear. There were no witnesses, and the accident was only discovered when various parts of his body were found inside the log shuttle feeding the pulp mill.

- Pulpers screws
- Crusher for wood chips to feed biomass boilers

Access to this equipment and to ramps, conveyors or hoppers to feed them have to be guarded, regularly inspected, and fitted with the appropriate emergency stop systems. Nobody should be in a position where they can be drawn inside this type of equipment, by lack of concentration, because of a collapse, to the flow of material feeding the equipment, or an equipment failure itself.
