# WISE NEWS

## Workplace Industrial Safety and Environment Newsletter

# FORKLIFT FATALITY—INVESTIGATION

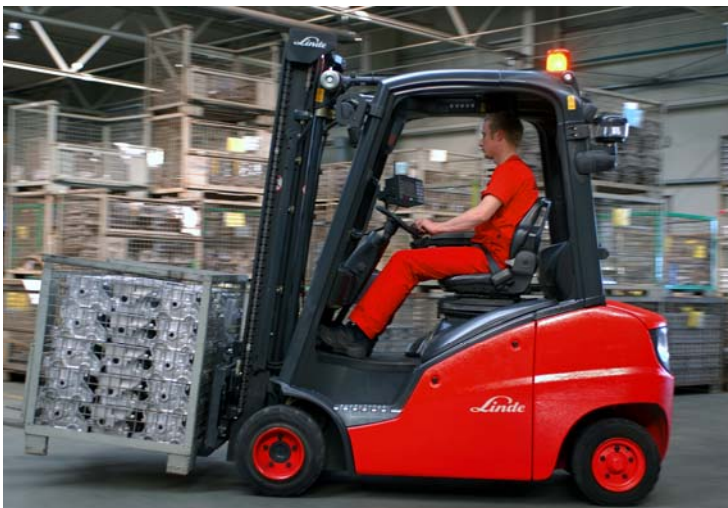
Source: Linde

1. This internal roadway is a common thoroughfare for mobile equipment and pedestrians.
2. There are genuine 'visibility' concerns driving in a forward direction, and there are ergonomic issues associated with driving in reverse over anything more than a small distance.
